Accidental Excavator Activation

M. Junge, A. Peuser, I. Pedal

3. International Congress of Forensic Medicine, Damascus, Syria, 04/03/30

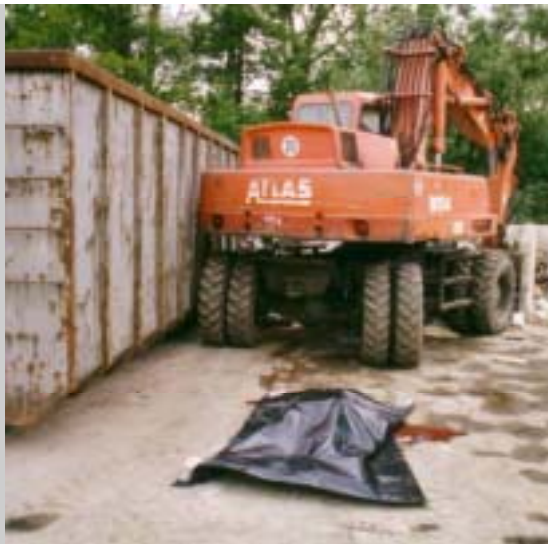
Excavator and Container at the death scene after recovery of the corpse (rear view).

During Recovery the excavator was driven forward, for about 1.0m.

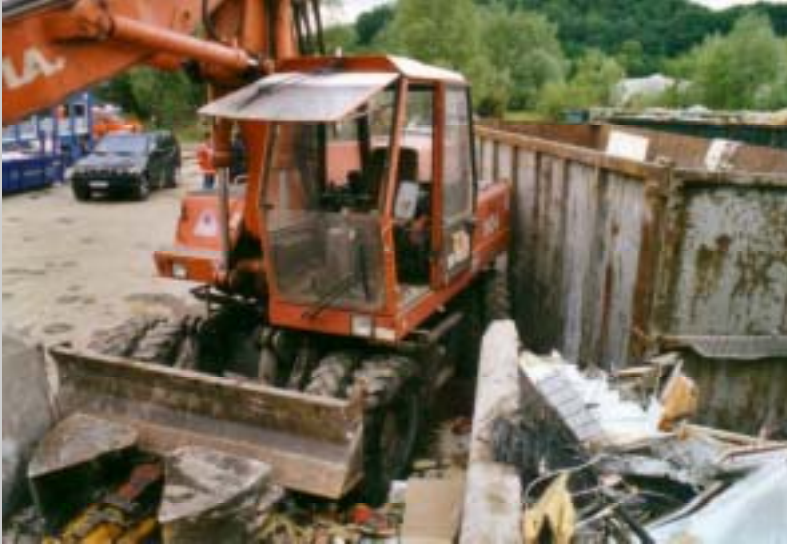
Front view, death scene

The front view is shown in the next slide: Container, concrete dividers, scrap metal.

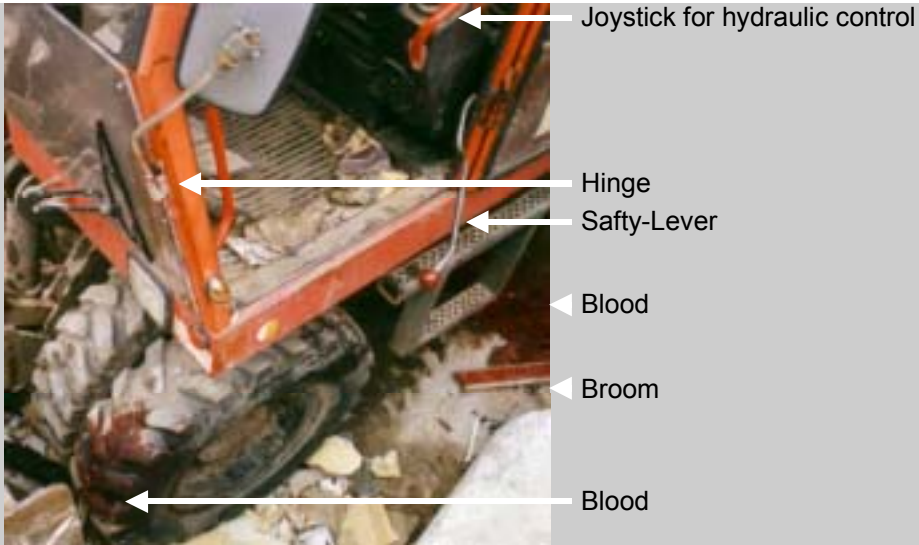
Final position of the Excavator

In order to recover the driver the emergency services moved the excavator forward for about 1m in a right-hand turn. This final position is shown in the slide.

This slide shows a detailed look into the lower portion of the left side of the drivers cabin: Base of the operator control joystick, front hinge, broom, blood on the concrete floor as well as corresponding stains on the left front wheel. Both blood stains do not correspond due to the moving of the excavator by the emergency services.

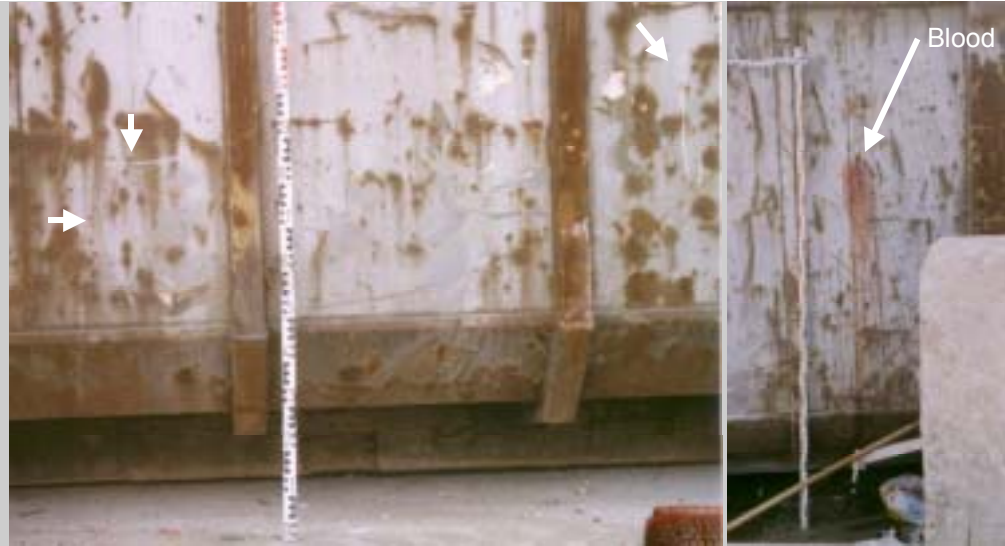
Container Side-View, Excavator Imprint

The Impact of the excavator can be seen on the side of the scrap container. Its imprint is highlighted with chalk marks and these are marked with arrows in the slide. Bloodstains were found on the side of the container—just in front of the excavator cabin.

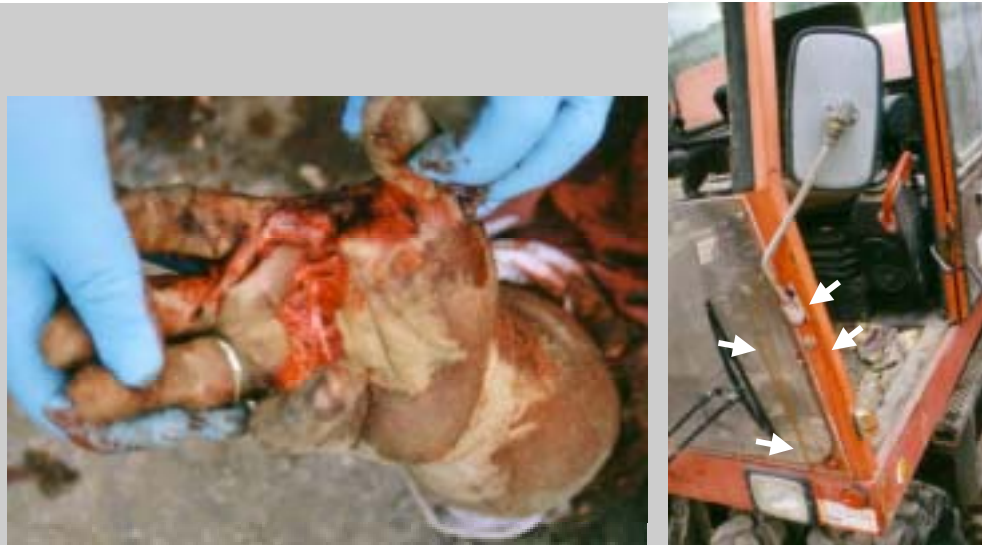
Right palmar injury correlating to the hinge of the rear-view mirror

Crush marks were found on the palmar face of the right hand. The cylindrical injury could be correlated to the hinge of the left front mirror, welded to the left frontal column of the driver's cabin. A death due to a crushed skull with severe damage to the brain tissue—resulting from a blunt object—was diagnosed during autopsy.

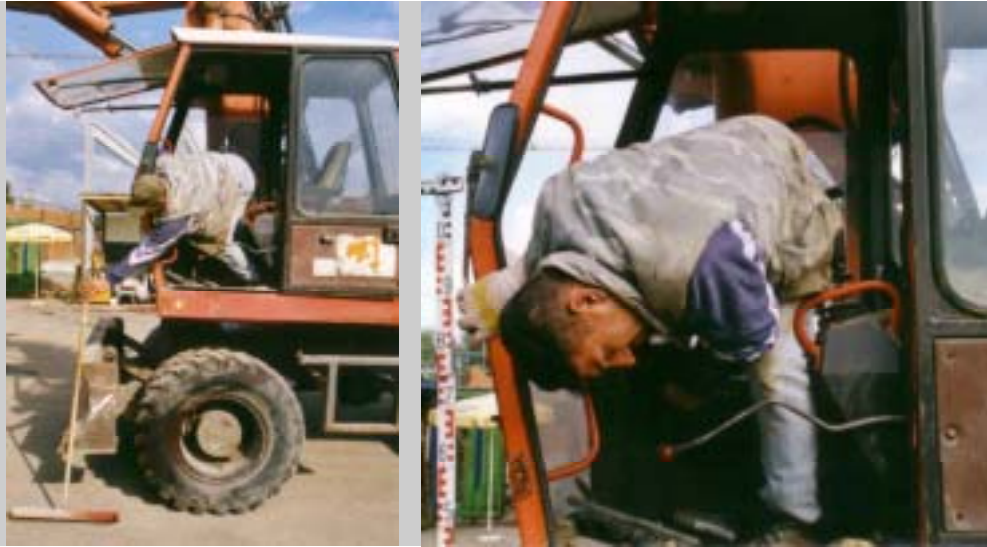
Reconstruction

Using these pieces of information the accident could be reconstructed:

The driver was leaning outside the left door of the drivers cabin, supporting his weight by gripping to the hinge of the left front mirror, while trying to get hold of the broom with his left hand. While extending his arm out to the broom, he accidentally hit the joystick used for rotating the excavator with his thigh. During the resultant turning of the excavator his head got caught between the container wall and the frontal column of the driver's cabin. His right hand, still clinging to that hinge, got crushed when the cabin hit a rib on the wall of the container.

Safety regulations require a deactivation of the hydraulic system before leaving the driver's position. Would these regulations have been adhered to the accident would have been avoided.
